**Docket No. 217 – Development and Management Plan Inspection**

Northeast Utilities Service Company Certificate of Environmental Compatibility and Public Need for the construction of a 345-kV electric transmission line and reconstruction of an existing 115-kV electric transmission line between Connecticut Light and Power Company's Plumtree Substation in Bethel, through the towns of Redding, Weston, and Wilton, and to the Norwalk Substation in Norwalk, Connecticut.

**Norwalk Substation**

**Date:** March 8, 2006

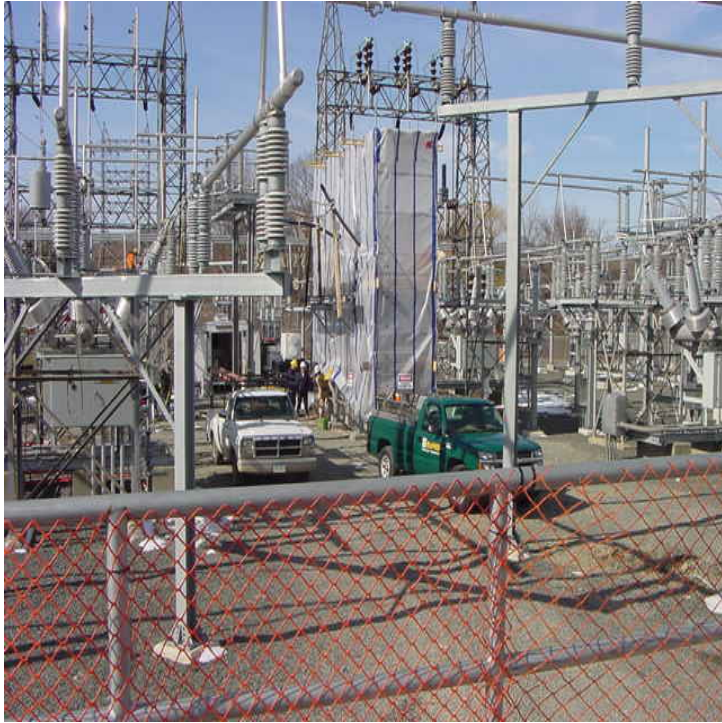
- Some work continues within the live yard. 3/8/06.	- None at this time. Work remains controlled. 3/8/06.	-N/A.
Erosion and Sediment Controls	- Sediment accumulation continues in the stone onsite at one of the access gates. This is a result of offsite stormwater and roadway sand 1/4-3/8/06.	-None at this time. 3/8/06.	-N/A

Norwalk Substation: Photo on the left shows work continuing within the live yard. Photo on the right shows the muddy conditions in the area near the GIS building. Materials have been cleared from this area

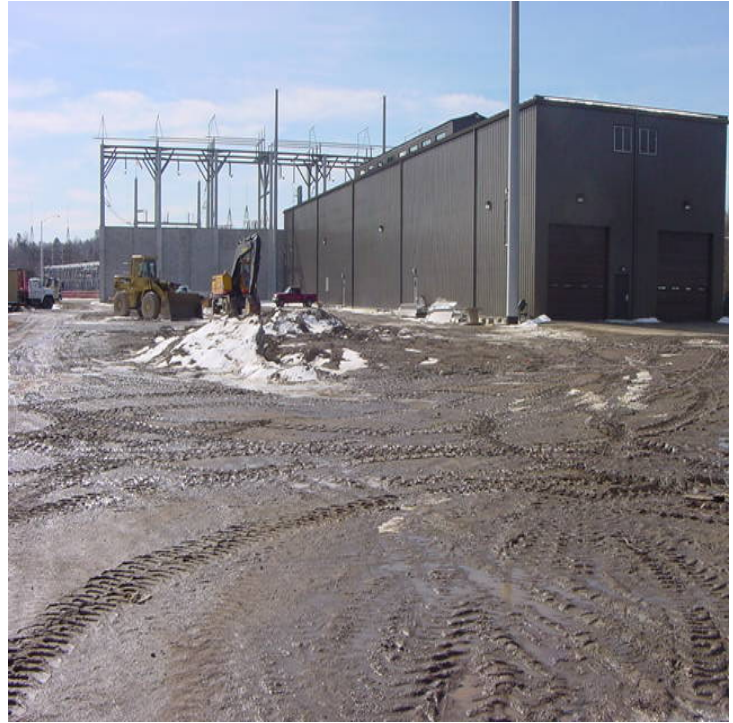
as part of the general site cleanup. 3/9/06.

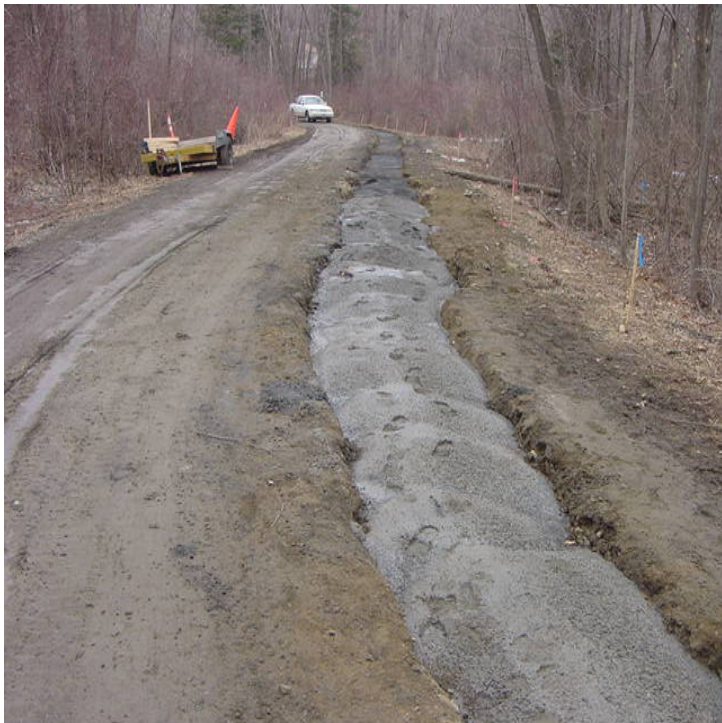
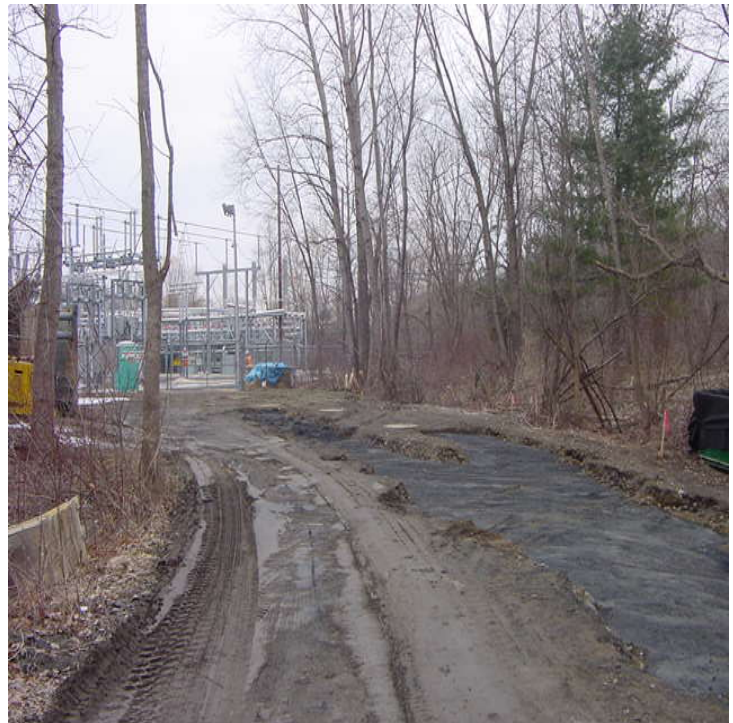
Areas of Inspection	Observation	Recommended Action	Corrected Action
Access Roads	- Trenching continued in the driveway to the substation as part of the 345kV XLPE work. 2/23-3/9/06.	<ul style="list-style-type: none"> <li>- Work remains well contained and does not involve the substation yard. 3/9/06</li> <li>-If the driveway needs to be plowed, keep</li> </ul>	<p>-N/A.</p> <p>- N/A</p>

Both photos show the access drive to Plumtree Substation where trenching and backfilling for the 345kV XLPE portion of the project is occurring. Work is well contained to the driveway at this time. 3/9/06
